# CASE REPORT

## Single Unit Implant Placement in the Esthetic Zone- Truly a challenge

Dr. Lanka Mahesh, Dr. Manesh Lahori, Dr. Ankur Aggarwal

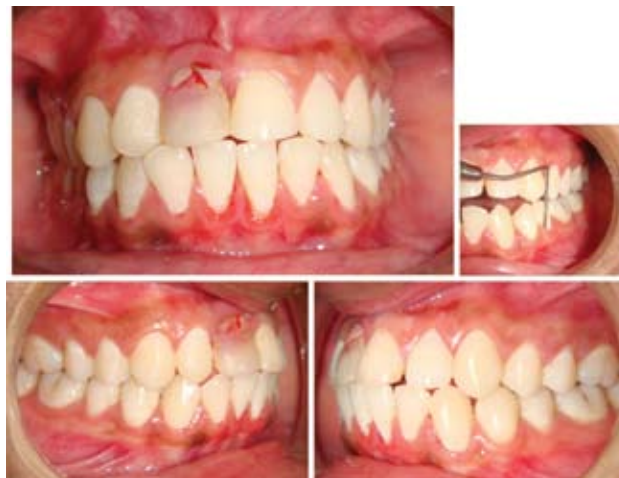
20 year patient presented with the chief complaint of her front tooth turning red.

Clinical examination revealed internal resorption of her maxillary right central incisor due to trauma 10 years back.

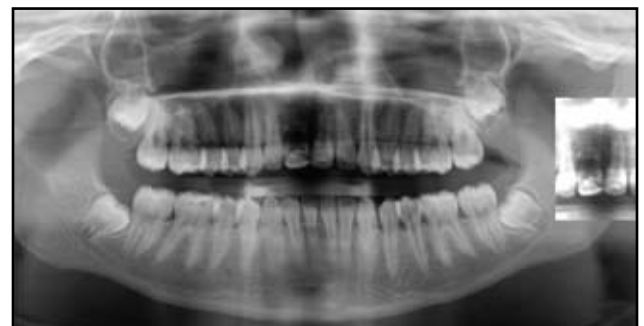
Panoramic radiograph shows internal resorption

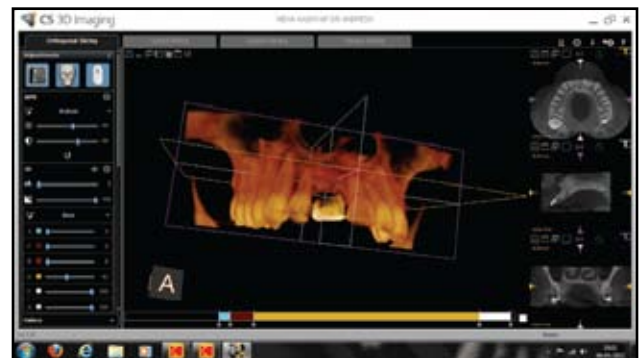
CBCT scan

dentition, good periodontal health, and fair oral hygiene. Radiographic examination revealed total internal resorption of the root of the central incisor. A CBCT scan using a Kodak 90003D was performed to assess the amount of bone in the right central incisor region. Adequate alveolar width of 6.3 mm and alveolar height of 14.5 mm was measured on the scan.

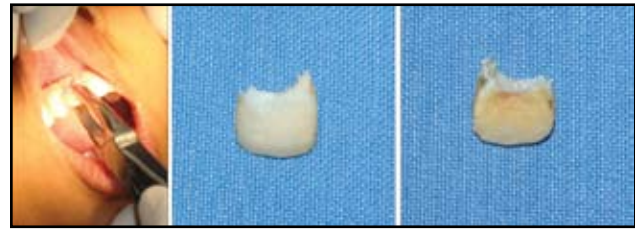
Extraction of the resorbed tooth

The tooth was extracted atraumatically. Since most of the root was resorbed, simple extraction forceps were used.

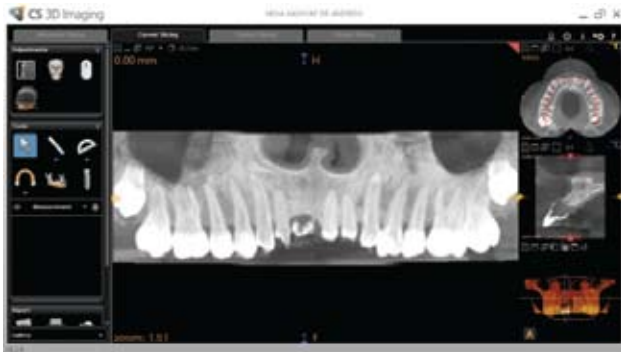
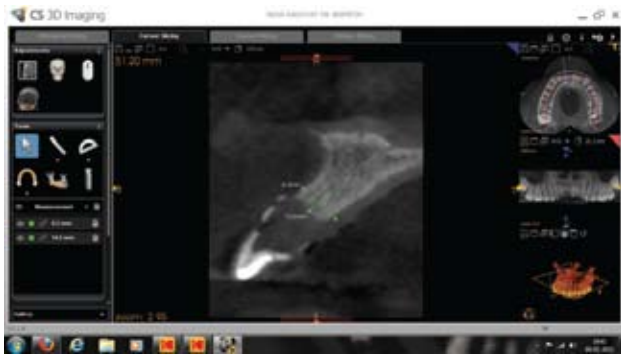
Alveolar width - 6.3mm Alveolar height- 14.5mm

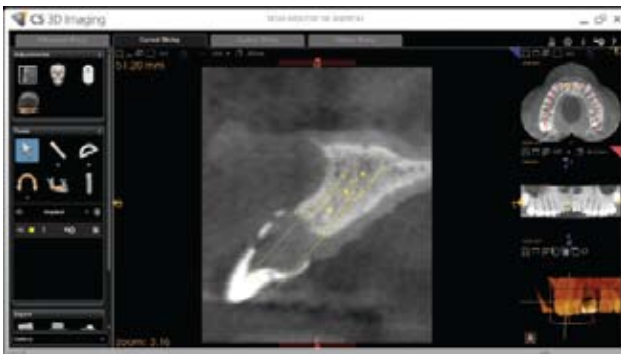
Implant Planning 3.75 x 11.5 mm

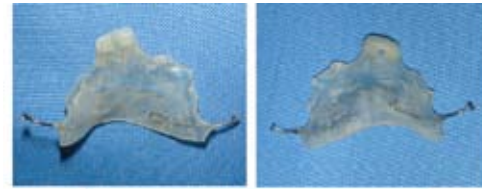
Acrylic surgical stent

An acrylic surgical stent was used and a 3.75 x 11.5mm ADIN Spiral Tapered Implant was placed making sure the implant is 2.5 mm away from the future gingival margin. Healing collar or abutment was simultaneously placed on the implant. This was followed by placement of PTFE cytoplast sutures with suture removal 14 days post op. During the healing phase an EMAX lithium disilicate Maryland type bridge was fabricated and bonded for esthetic reasons.

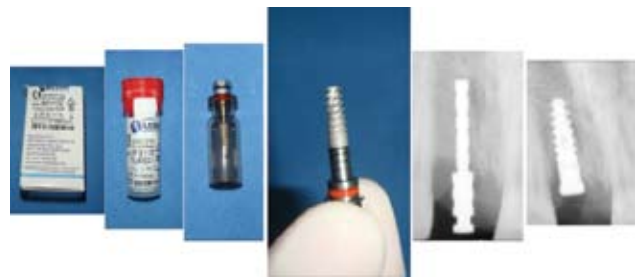
3.75 x 11.5mm ADIN Toureg Implant

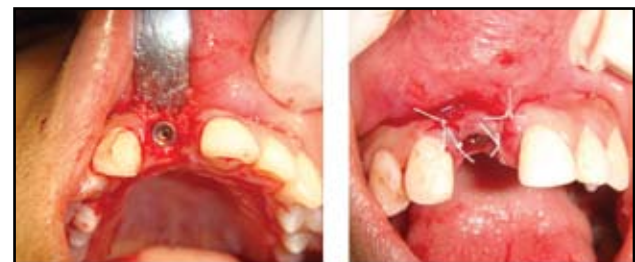
PTFE cytoplasm sutures in place

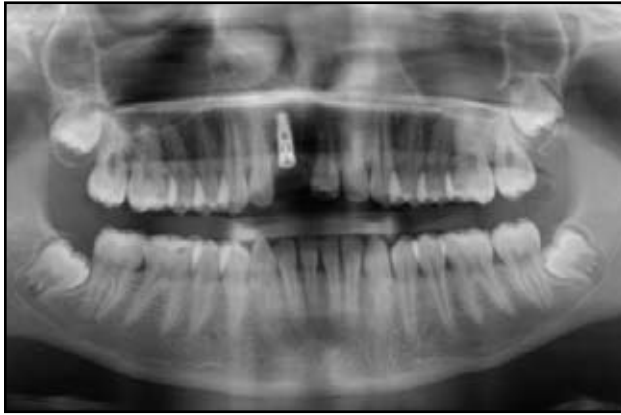
Post operative panoramic radiograph

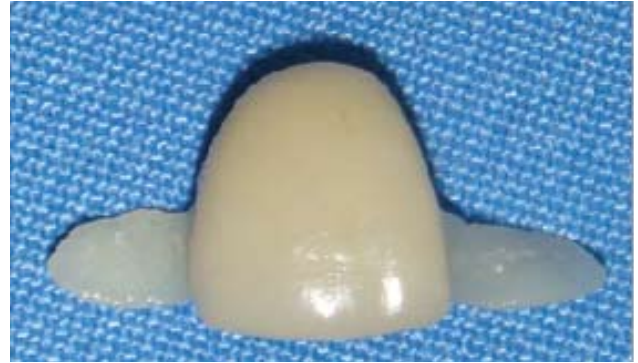
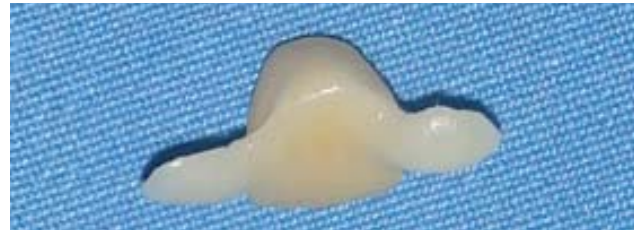
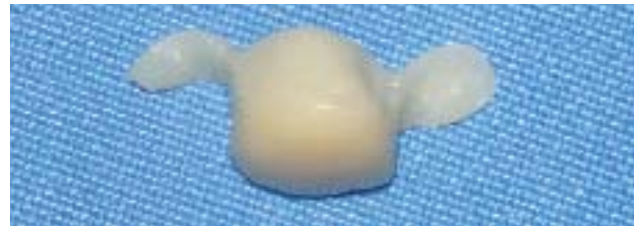
Lithium Disilicate Provisional Maryland type bridge (EMAX)

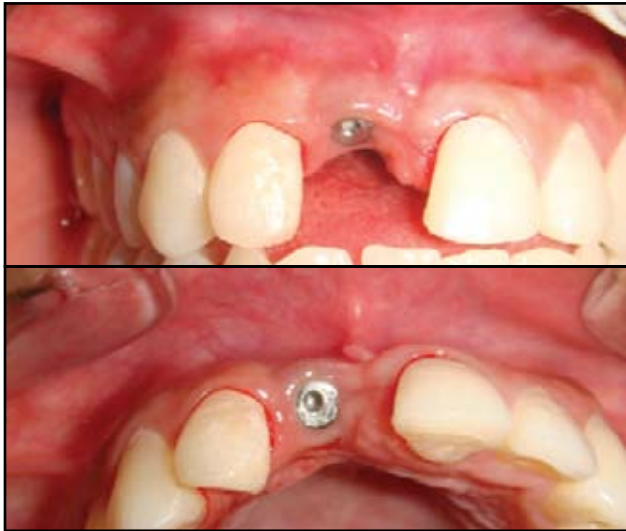
Provisional removed. Healing collar visible.

Good oral hygiene was advised with frequent checkups and oral prophylaxis. After a healing period of 3 months, the EMAX provisional was removed and indirect open tray fixture level impressions were made. The casts were articulated and mounted on a semi adjustable Hanau articulator. A zirconia abutment was CAD CAM milled over which an EMAX crown was fabricated. The abutment was then gently screwed and torqued in the implant and then the all ceramic crown was luted. We were able to achieve good esthetics with excellent shade matching .

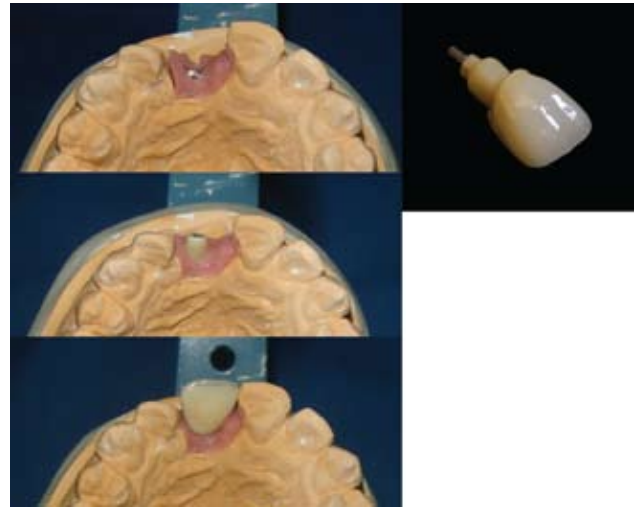
Customized zirconia abutment with Lithium Disilicate (EMAX) crown.

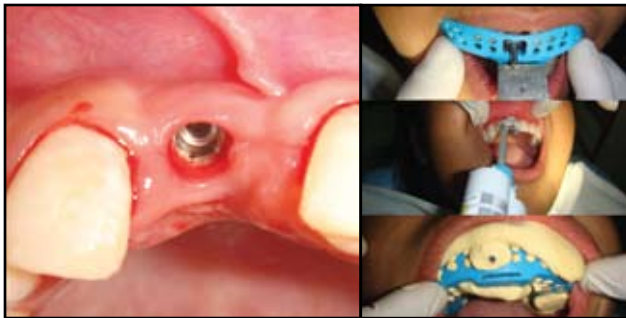
Healthy soft tissue cuff around the implant neck

Open tray fixture level indirect impression

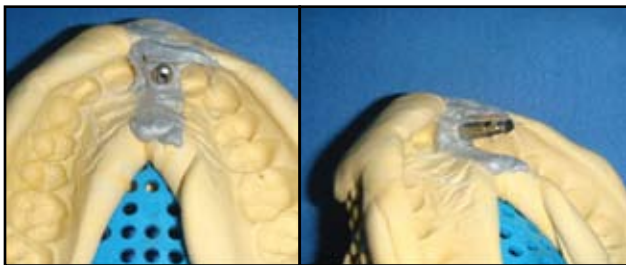
Transfer coping in the impression

Implant analog attached to the transfer coping.

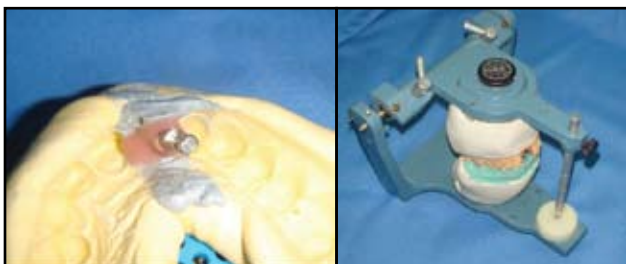
Gingival mask applied to mimic soft tissue

Hanau semi adjustable articulator

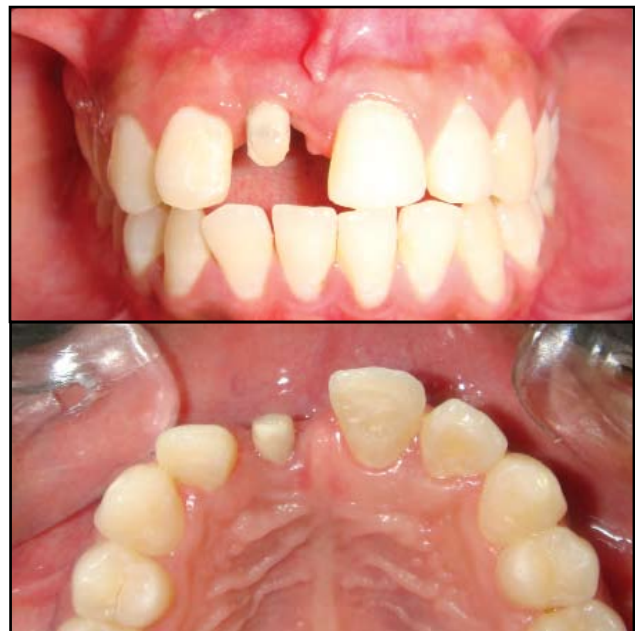
Zirconia abutment attached to the implant. Access hole is filled with composite.
